Inspection Logbook

for vehicles with a freight security
certificate
in accordance with DIN EN 12642 – Code XL

Walking-floor Semitrailers, Payload 34500 kg

Inspection Logbook No. 283162

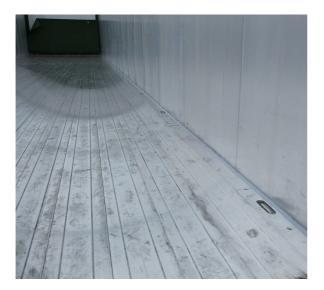
Please check the various designs of load securing and lashing equipment for damage and proper operability. Also check that their mounting elements are tight.

Lateral lashing bracket next to the walking-floor
